Morphological change on Cua Dai Beach, Vietnam: Part I image analysis

Nguyen Trung Viet¹, Vo Cong Hoang^{2,3} and Hitoshi Tanaka⁴

Abstract

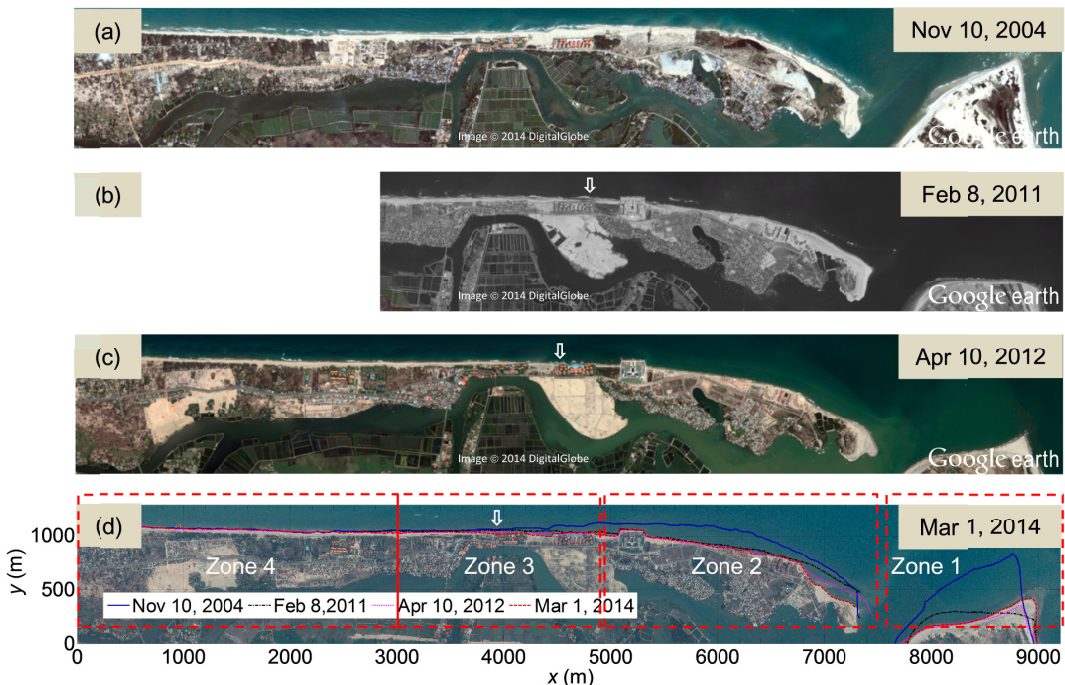
Fig. 2 Aerial photographs and detected shoreline positions of study area (Google Earth)

(a) Nov 10, 2004; (b) Feb 8, 2011; (c) Apr 10, 2012; (d) Aerial photograph on Mar 1, 2014 and detected shoreline positions. (white arrow showing the location of sandy beach wedge toe at each time)

According to the satellite images analysis, very interesting results showing that the wedge toe of sandy beach on the left side of river mouth propagates to the north. Location of wedge toe at each time is represented by white vertical arrow in Fig. 2. In addition, according to the field observation data in December, 2014, the location of beach wedge toe is shifted about 900m toward to the north from the

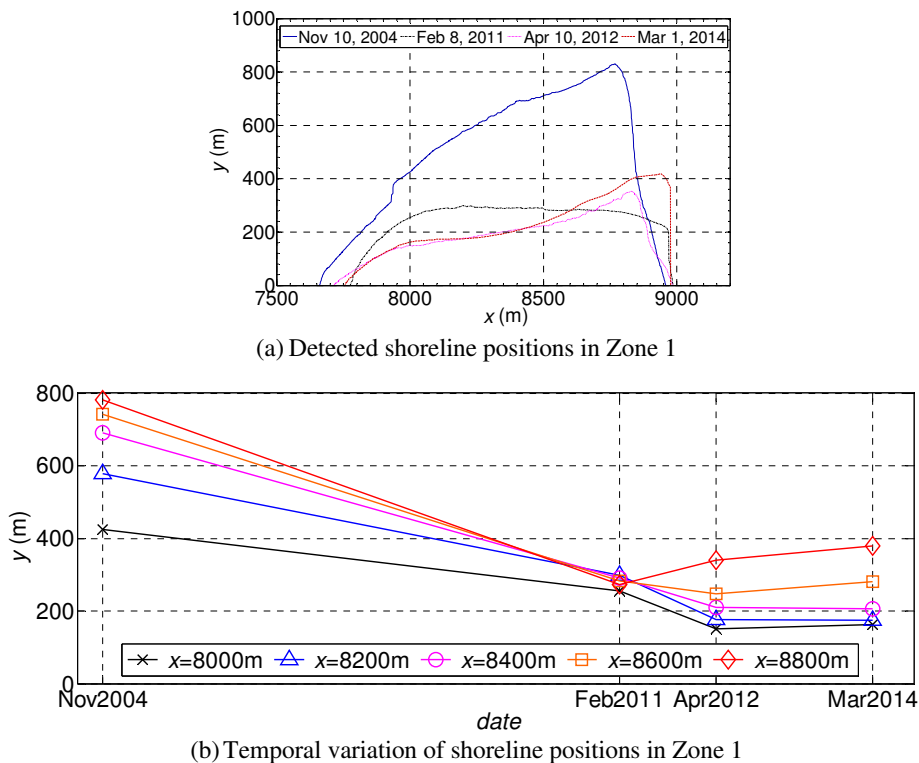
Fig. 3 Detected shoreline positions and temporal variation of shoreline positions in Zone 1

Figures 3(a) and 3(b) show detected shoreline positions and temporal variation at transections of shoreline position of the beach on the right side of the Cua Dai River mouth, respectively. According to those figures, shoreline position in this zone has been retreated about 500m in the period from 2004 to 2012. However, it has been stable after that, in the period from 2012 to 2014. In addition, it can be observed that the tip of this sandy coast is migrated to the south.

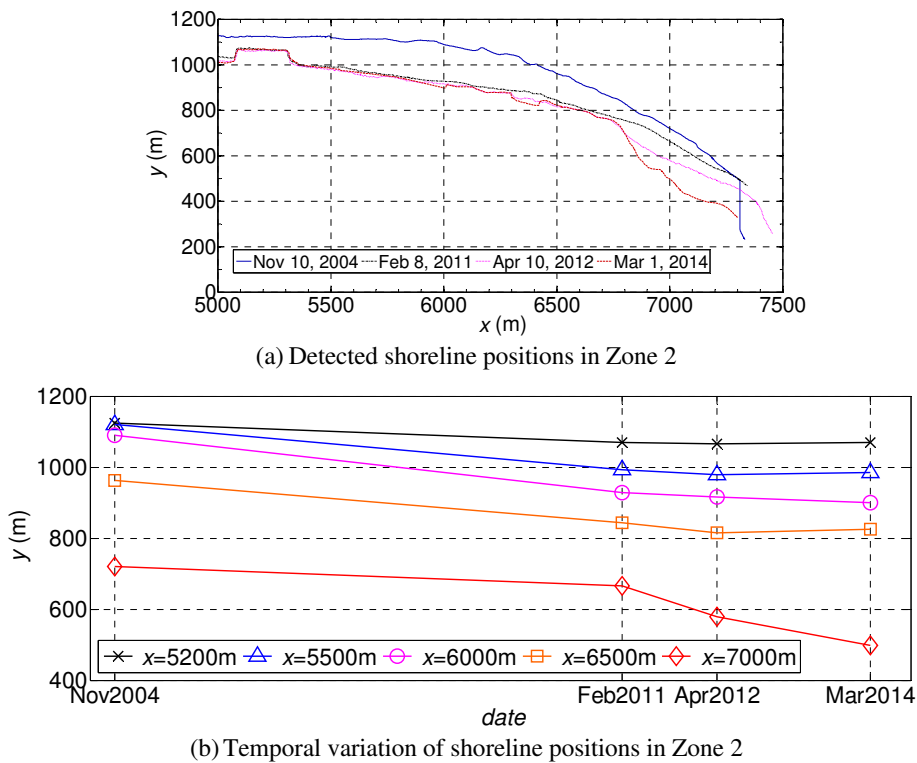
Fig. 4 Detected shoreline positions and temporal variation of shoreline positions in Zone 2

Figures 4(a) and 4(b) show detected shoreline positions and temporal variation at transections of shoreline position of the beach adjacent to the left side of the Cua Dai River mouth, respectively. Shoreline position in this zone has been retreated about 200m in the period from 2004 to 2014. The erosion in this zone has been occurred since a long time, and it has most serious erosion compared to other zones. The beach on the close side of river mouth has more significant erosion than the beach on the far side. The beach on the left side of Cua Dai River mouth is the famous place for tourist. Hence, since 2004, resort hotels have been constructed along this beach [Fig. 2(a)]. At that time, sandy beach was still remained in front of the hotels. However, after the severe erosion these hotels are now locating protrusion into the seawater body, for instance, Sunrise Hoi An Beach Resort. The sandy beaches vicinity to this hotel are eroded severely. The hotel plays the role as groin in the coastal area. It is similar to the case of the hotel on Nha Trang Beach which reported by Viet et al. (2014). For the safety of tourism facilities in this area, some

parts of the beach have been protected by sheet pile seawall. At these locations, the erosion of the sandy beach on the back side of seawall due to overtopping waves is very serious. It caused collapsing of resort hotels. At the locations without protection of hard-structures, severe retreat of shoreline can be observed.

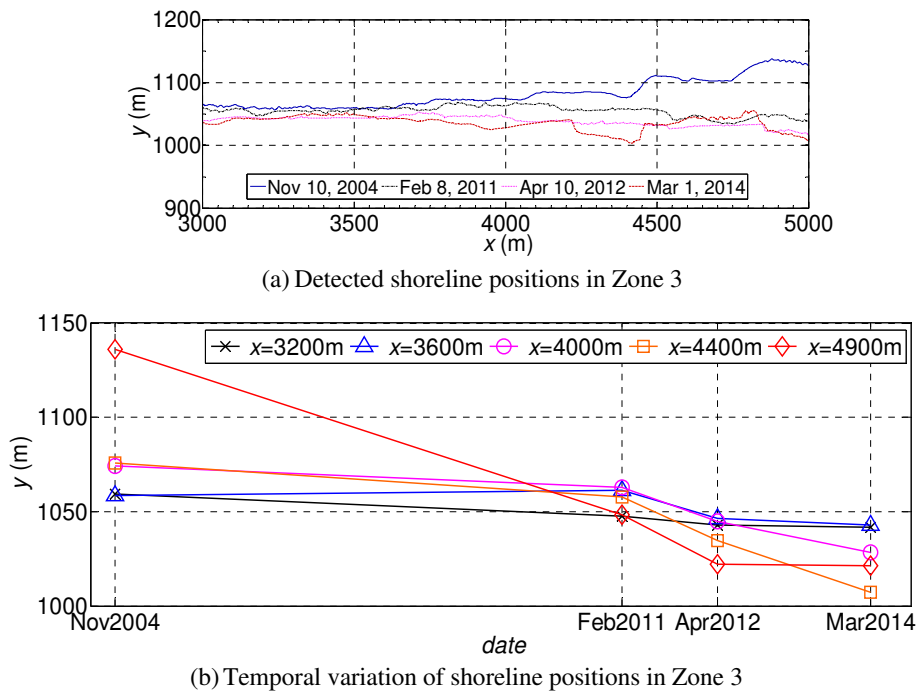
Fig. 5 Detected shoreline positions and temporal variation of shoreline positions in Zone 3

Zone 3 is adjacent to the north side of Zone 2. The right boundary of this zone is about 2500m to the left side of the Cua Dai River mouth. Detected shoreline positions and temporal variation at transections of shoreline position of the beach in this zone are presented in Figs. 5(a) and 5(b), respectively. The amplitude of beach erosion is decreasing from the right side to the left side in this zone. It is about 120m on the right, whereas about 30m on the left.

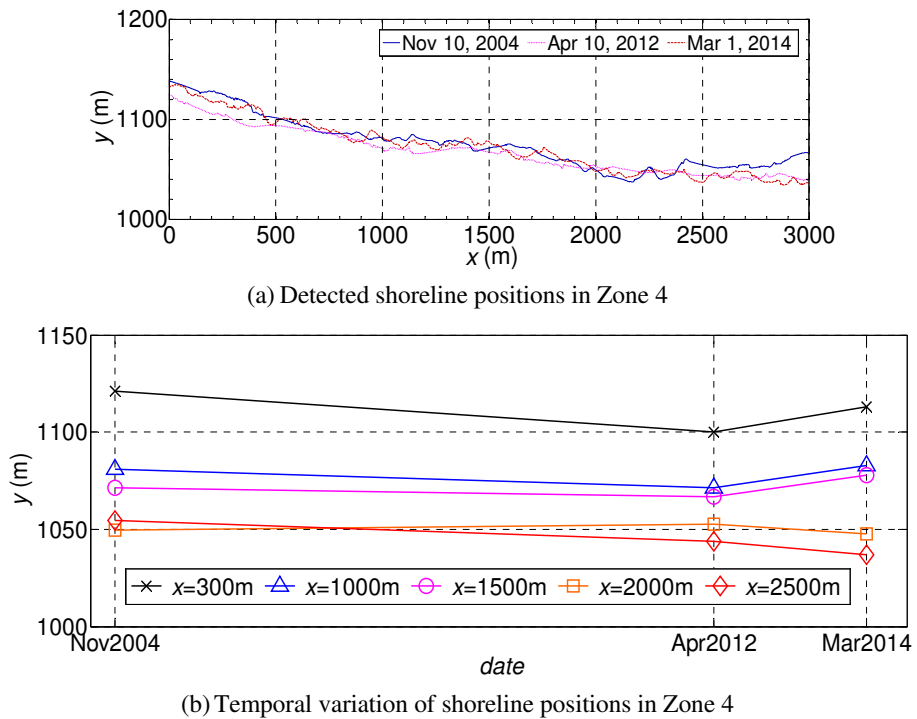
Fig. 6 Detected shoreline positions and temporal variation of shoreline positions in Zone 4

Figures 6(a) and 6(b) show the detected shoreline position and temporal variation at transections of shoreline position of the beach in Zone 4. This zone is located adjacent to the north side of zone 3. Shoreline data in 2011 is not available for this zone. According to the results presented in Figs. 6(a) and 6(b), shoreline positions in this zone are rather stable. Only slightly advance of shoreline can be observed at some locations on the north side of the zone.
