## DYNAMIC CHARACTERISTICS OF A HISTORICAL MASONRY BUILDING LOCATED IN AKITA

Carlos Cuadra\*

### ABSTRACT

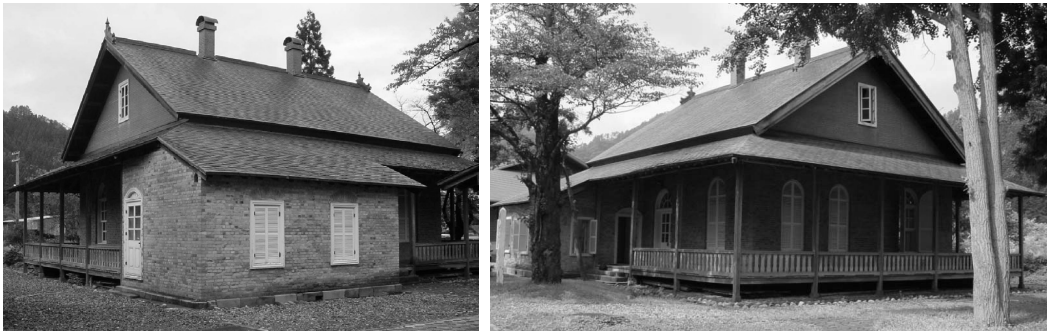
The building object of the present study is located at Ani village in Akita prefecture and it was constructed during the 12<sup>th</sup> year of the Meiji period (year 1879). It was constructed to host Adolf Mecker, a German engineer that came to Japan to work in the mines at Akita region. As can be observed in Figure 1, the main structure is formed by the masonry walls and complemented with wooden elements that form a kind of fence around the building. The architectural style corresponds to Gothic Renaissance with some arches at doors and at windows. The masonry units were fabricated with clay of the zone and burned in a factory constructed for that specific purpose. The design and the direction of the construction of the house were done by Mr. Mecker himself.

Figure 1. Target building (Ani Ijinkan)

The building under study, have suffered the action of some earthquakes, and the most recent was the Moriyoshiyama earthquake in the year 1982. This earthquake was a near source earthquake and destroyed partially the building. The prefecture government reconstructed the building replacing the triangular gable wall of the second story by light material instead of clay brick masonry. Then, only the first floor walls remain with the former clay brick jointed with cement mortar.

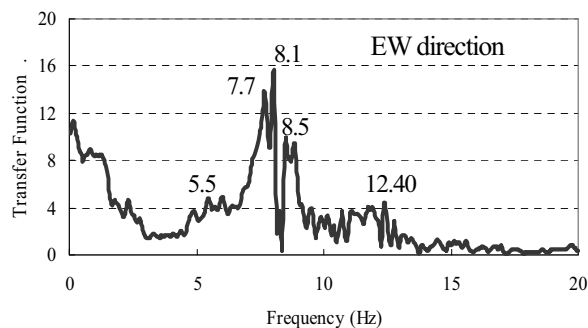
Figure 3. Transfer function for EW direction

However, based on microtremor measurements results verified by analytical modeling, it was possible to identify the predominant mode of vibration of the building that corresponds to the horizontal normal mode of vibration of the whole structure. The values of 7.7 Hz and 7.0 Hz around one of the predominant peaks in the EW direction and in the NS direction

were identified (Fig. 3 and 4). The other peaks can be explained as higher modes of vibration that would correspond to the vibration of walls. Also, a small peak around 5.5 Hz was detected (Fig. 3), which could correspond to the vibration of the chimneys of the building.

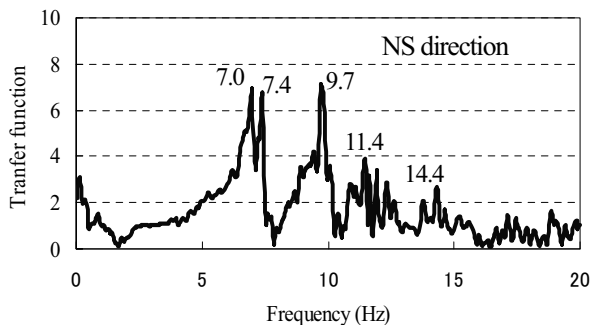
Figure 4. Transfer function for NS direction

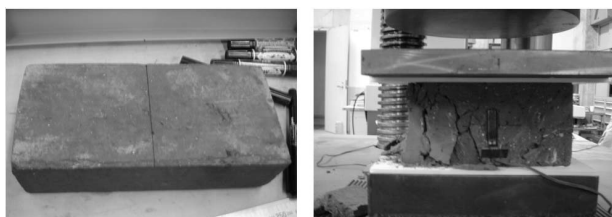
Brick units taken from a stock of the target building were tested to determine their physical and mechanical properties. It was difficult to distinguish the brick units of the stock used during former construction works from those used for repairing works. Independently of this condition, units of good appearance were selected for laboratory tests (Fig. 6).

Figure 6. Masonry brick unit and compression test

Compression tests were performed to obtain the values of strength and Young modulus. However, high values of these mechanical properties were obtained, which could be due to the size of test pieces. Apparently, the height of specimens was not enough to avoid the confinement effect produced by the constraint of lateral sides of brick units. Therefore, this constraint could be one of the factors of apparently high values for elastic properties. Then, slender specimens and the inclusion of joint mortar as well, would be necessary for appropriate characterization of masonry walls. As reference, the values of water suction ratio, density, compression strength and modulus of elasticity obtained from brick units are shown in Table 1.
