An evaluation of the dynamic properties of traditional wooden shrines located in Yurihonjo, Akita

Carlos Cuadra *

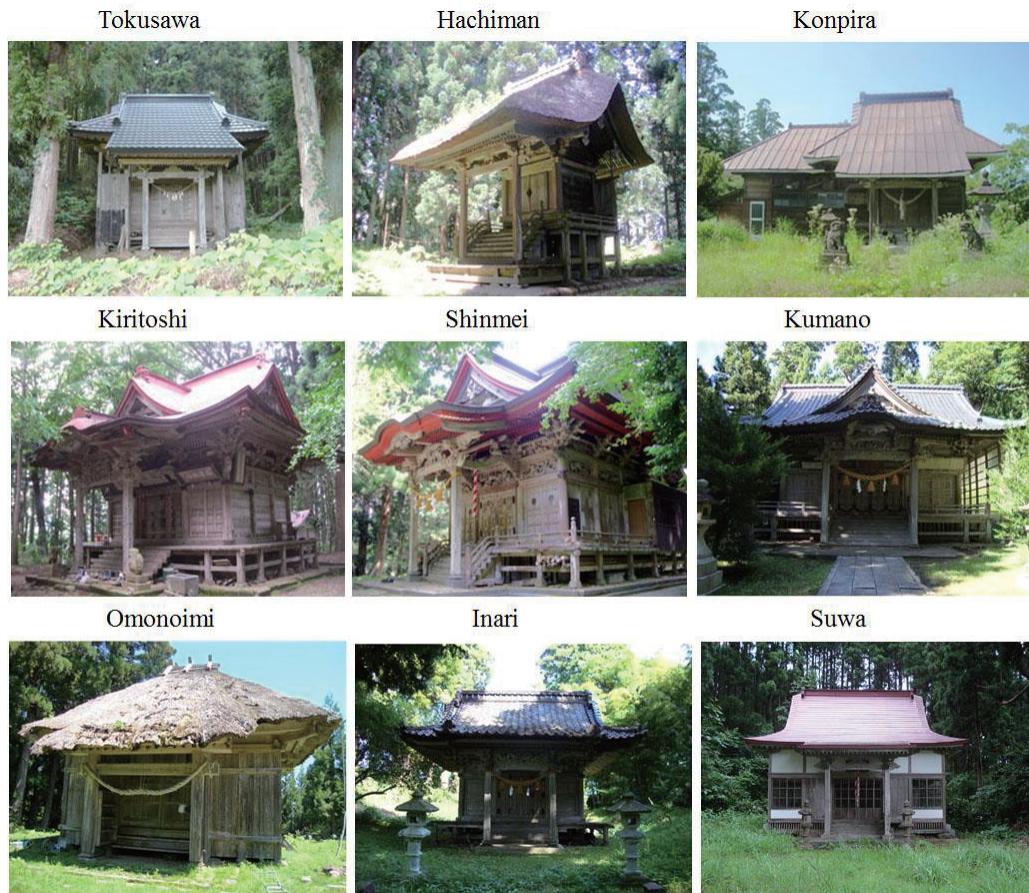
Fig. 1. Selected temples for the present study

With exception of Tokusawa temple that is located near a vegetable field, all temples are located in the upper part of hills. The structure of all temples corresponds to a traditional wooden frame. The Tokusawa, Kumano and Inari temples have tile roof, the Hachiman and Omonoimi have thatched roof, and the Konpira, Kiritoshi, Shinmei and Suwa have thin steel plates as roof.

In Yurihonjo city area there are 11 temples that are declared as local cultural heritage. For this study 9 temples were investigated to determine their dynamic characteristics. Micro vibration measurements and the correspondent analysis were performed in these selected buildings. Photographs of some of these selected structures are shown in Figure 1. The dimensions of these buildings range from approximately 5 m by 5 m for the smallest to 10 m by 10 m for the largest dimensions in plan. Structures correspond to framed wooden constructions with traditional connections between columns and beams. In general, nails are not used in these joints, and instead of them, the beam is narrowed at extreme to be inserted into a hole cut in the column. These buildings are supported by columns that rest directly on stone bases forming pinned joints.

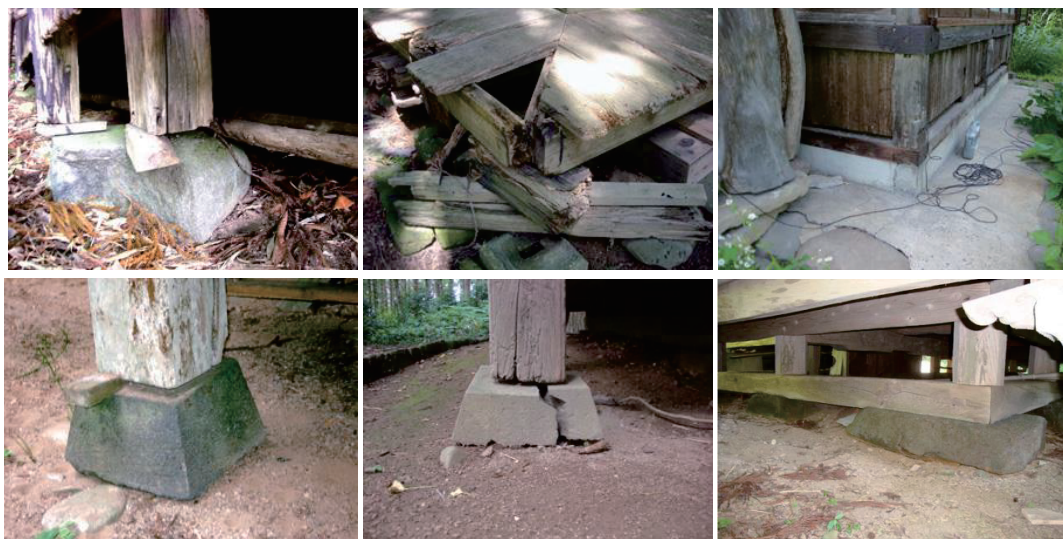
The main damage observed in some temples was the gap between the base stone and the bottom part of the columns as can be observed in Figure 2. Apparently, this failure is due to the deformation of the girders of the bottom part of the structure. In some cases the failure is a combination of the settlement for the central part of the building with the bending of the girder. Also some elements are seriously deteriorated by the weather action. In all of the cases was observed that the maintenance of the temples are poor and administration and management offices are always closed if they exist and in other cases there are no administration offices. In general these temples are open during the corresponding local festival and during New Year Celebration, the rest of the year are closed.

Fig. 2. Details of the damages at the bottom of columns

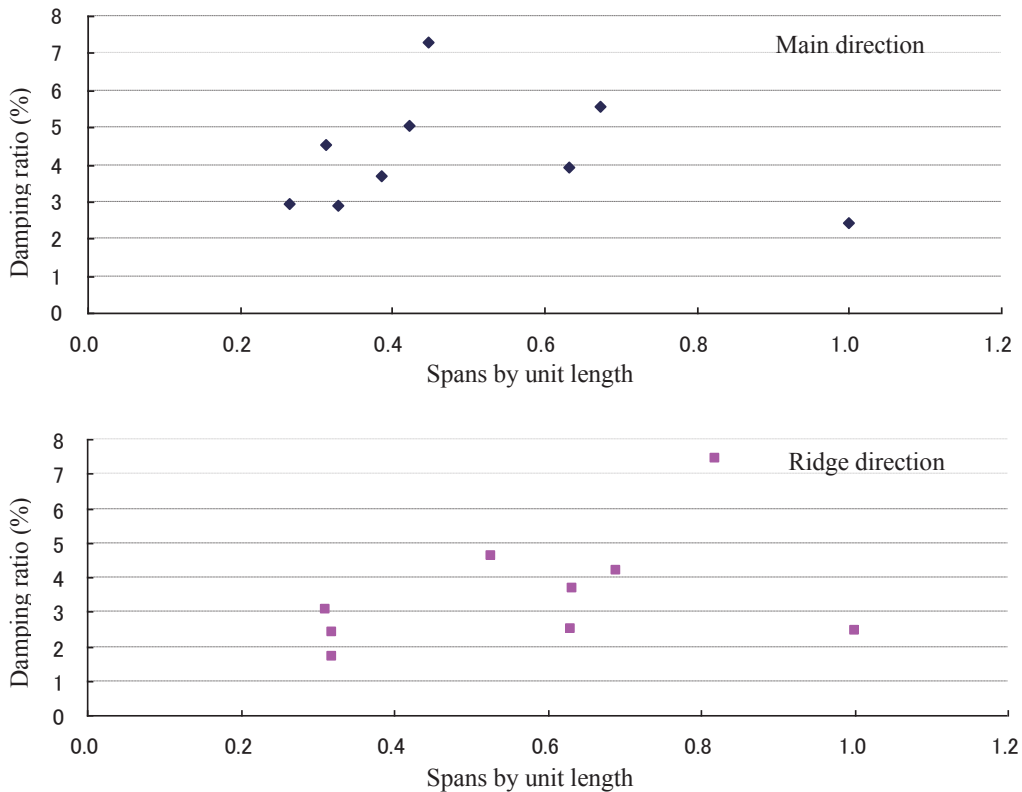
The damping factor ranges from approximately 2% to 7%. However in previous studies of other traditional temples smaller values of the order of 2 % are reported. This fact could indicate that temples with high values of the damping factor present higher potential for energy dissipation. However, it is believed that the energy dissipation occurs due to the lack of appropriate stiffness of joints and supports and therefore could be an indicator of the vulnerability of the structure. When the damping factor is related to the period of the structure or to the height of the structure unclear relationships are obtained. Therefore, in this research the ratio of the number of spans versus the length is taken to establish a relation with the damping factor. That is the number of spans by unit length is plotted versus the value of the damping factor as is shown in Figure 5.

Fig. 5. Number of span by unit length versus damping factor

It can be noted that with the exception of one temple, the general tendency is to have a larger value of the damping factor when the number of span by unit length is increased. It is supposed that when the number of span by meter increases the structure presents more joints that could increase the dissipation of energy. However, the condition of the joints is an important factor as well as the distribution of joints along the height of the building which consider the presence of horizontal structural element like secondary beam.

The damping factor were correlated with the number of spans of the structure and general tendency of increasing damping with increasing number of spans was found. However more analysis is required since it is believed that damping is strongly dependent of the number of joints and of the conditions of these joints.
