Assessment of river mouth variability after jetty and groyne construction: A case study of the Volta River mouth, Ghana

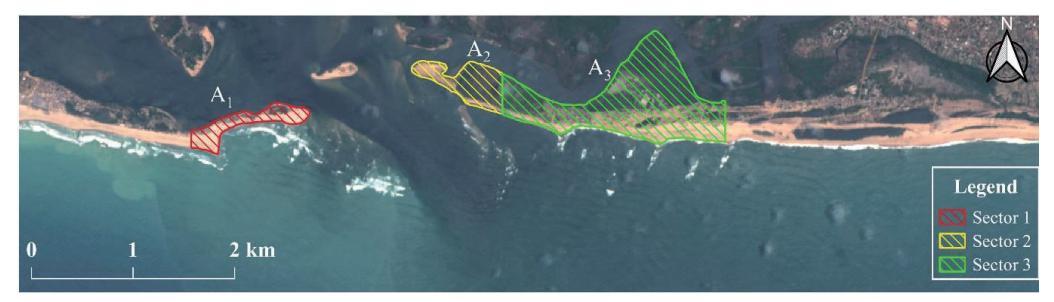
sandspit (red), Sectors 2 (yellow) and 3 (green) on the downdrift sandspit (Figure 2). Furthermore, the sandspit areas for each sector was estimated for the study period to depict accretion and erosion trends at the river mouth. For this analysis, the areas for Sector 1, 2 and 3 were denoted as A_1 , A_2 and A_3 , respectively (Figure 2).

Figure 2. Definition of the three sectors used in the river mouth variability analysis.

To ascertain the river mouth variability before and after the construction of the jetty and groyne system, the river mouth sandspits were divided into three sectors. These included Sector 1 on the updrift

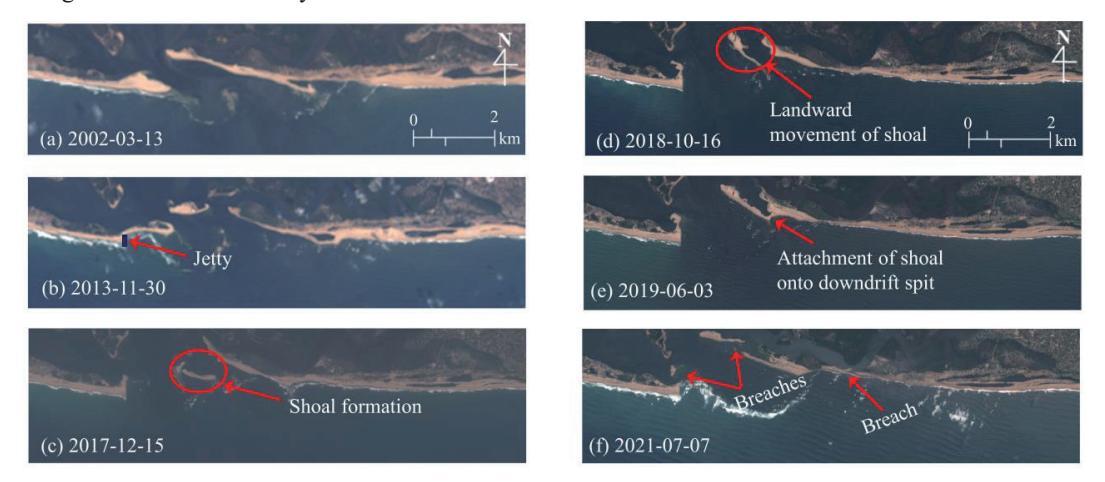
Within the study period, a number of morphological changes were observed at the Volta River mouth from the collected satellite images. The jetty at the river mouth was constructed with the purpose of halting the lateral migration of the updrift sandspit from the west to the east (Figures 3a and 3b). This resulted in an increase in the width of the river mouth which facilitated an efficient tidal exchange and channel navigation. In the years following the construction of the jetty, there has been the frequent formation of offshore shoals which could be attributed to changes in the water depth at the river mouth and wave breaking. These shoals move landward and attach to the downdrift sandspit which led to a reduction in the width of the river mouth (Figures 3c to 3e). In addition to this, the landward growth of the updrift sandspit is observed (Figure 4). A more recent development at the river mouth is the multiple breaching of the sandspits which has led to widening of the river mouth (Figure 3f). These distinct changes at the river mouth give an indication of the river mouth's response to alterations in the sediment budget at the river mouth by the ASDP.

Figure 3. Satellite images showing the various morphological evolutions at the Volta River mouth (2002 - 2021).

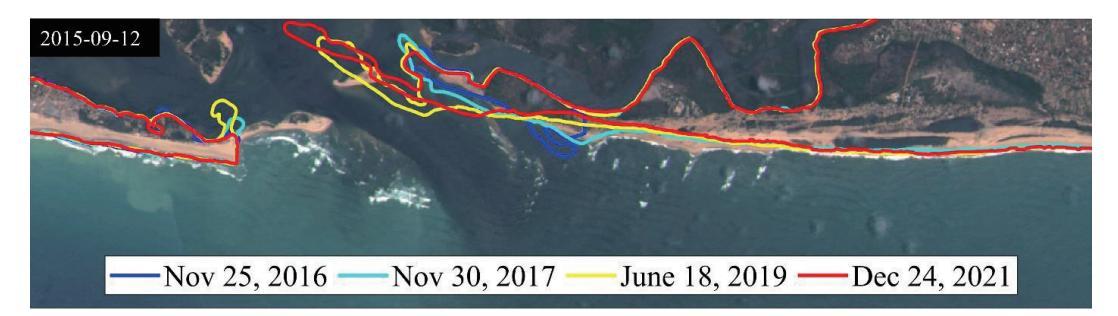
Figure 4. Shoreline variation of the Volta River mouth (2016 – 2021).

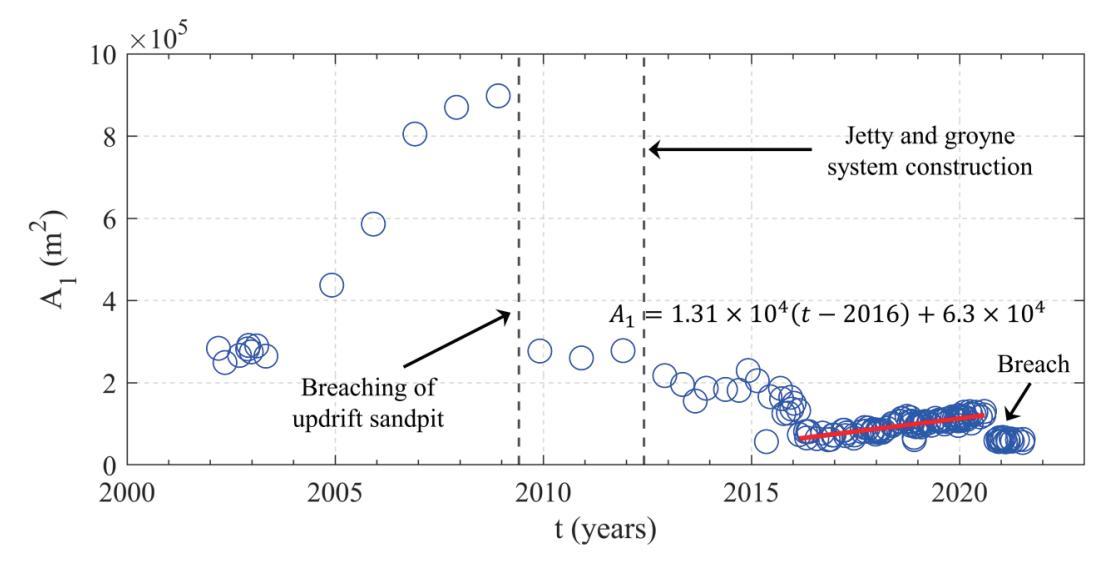
By plotting the sandspit area for the three defined sectors of the river mouth, the accretion and erosion trends can be assessed. Figure 5 shows the time variation plot of the sandspit area for Sector 1. Regression analysis for this sector after the jetty and groyne construction shows a sandspit area change rate of 1.3×10^4 m²/year from 2016 to 2020. The increment in sandspit area within this period is as a result of the intrusion of the updrift spit into the estuary induced by sediment bypassing the jetty and the action of breaking waves.

Figure 5. Updrift sandspit area variation for Sector 1.

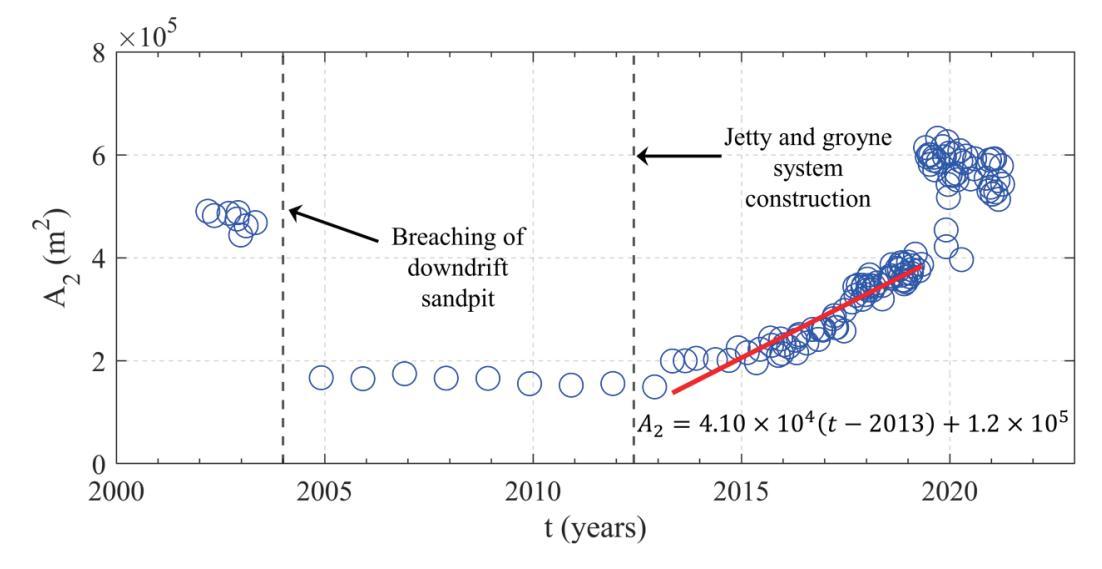
With respect to Sector 2 on the downdrift spit, the regression analysis revealed an area change rate of 4.1×10^4 m²/year from 2013 to 2019 (Figure 6). This gain in sandspit area was mainly due to the attachment of the offshore shoals to this section of the downdrift sandspit. Sector 3 on the other hand shows the exact opposite of both Sectors 1 and 2. The analysis showed a sandspit area change rate of -6.4×10^4 m²/year from 2013 to 2021 for Sector 3 (Figure 7). This corresponds to the shoreline retreat observed in Figure 4 for this sector of the river mouth. Table 1 shows a summary of the sandspit area change rate for the three sectors of the river mouth.

Figure 6. Downdrift sandspit area variation for Sector 2.

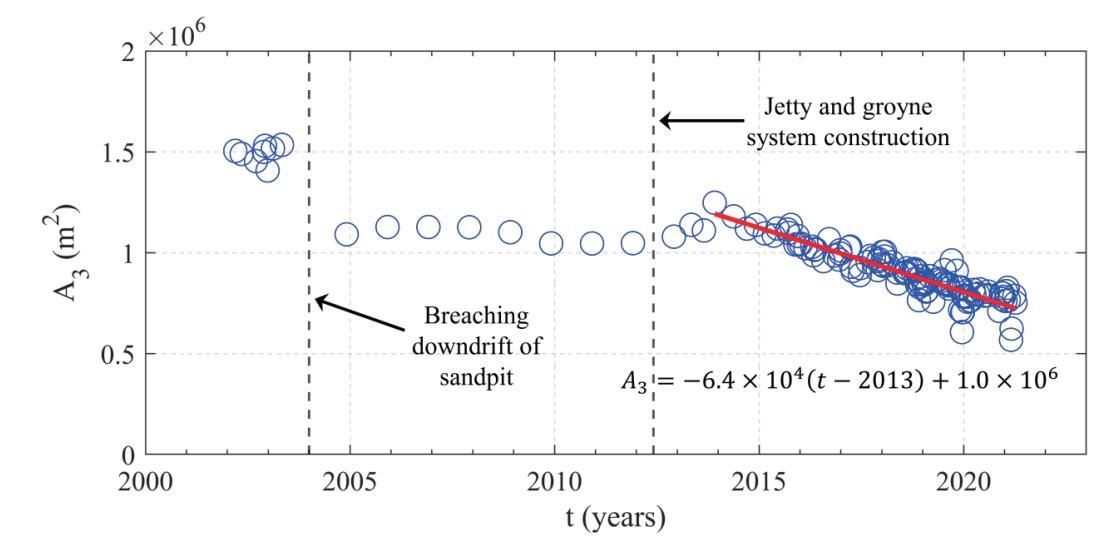
Figure 7. Downdrift sandspit area variation for Sector 3.
